DOCUMENTATION OF ENVIRONMENTAL INDICATOR DETERMINATION

Environmental Indicator (EI) RCRIS code (CA750)

Migration of Contaminated Groundwater Under Control

Facility Name: Greene, Tweed & Co.

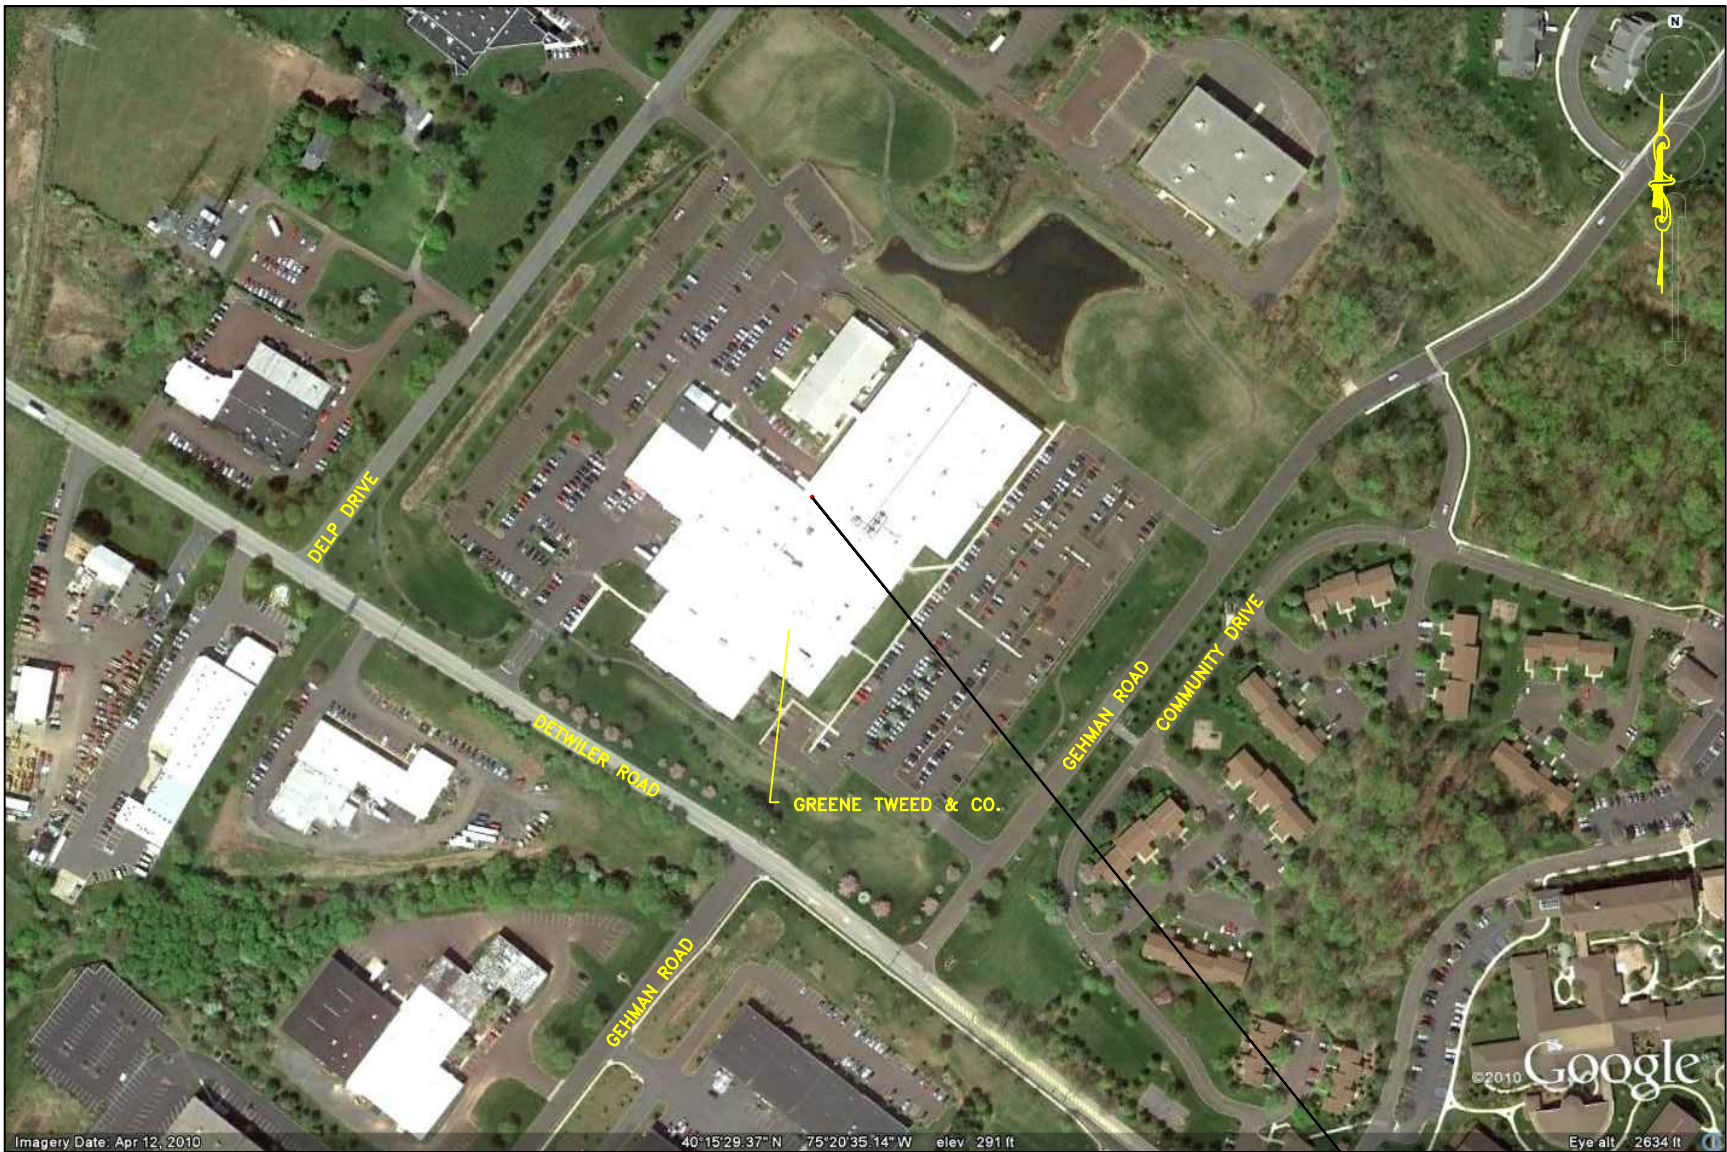
Comments: Location of 2002 Act 2 No. 6 Fuel Oil Release – Drainage Swale Area.

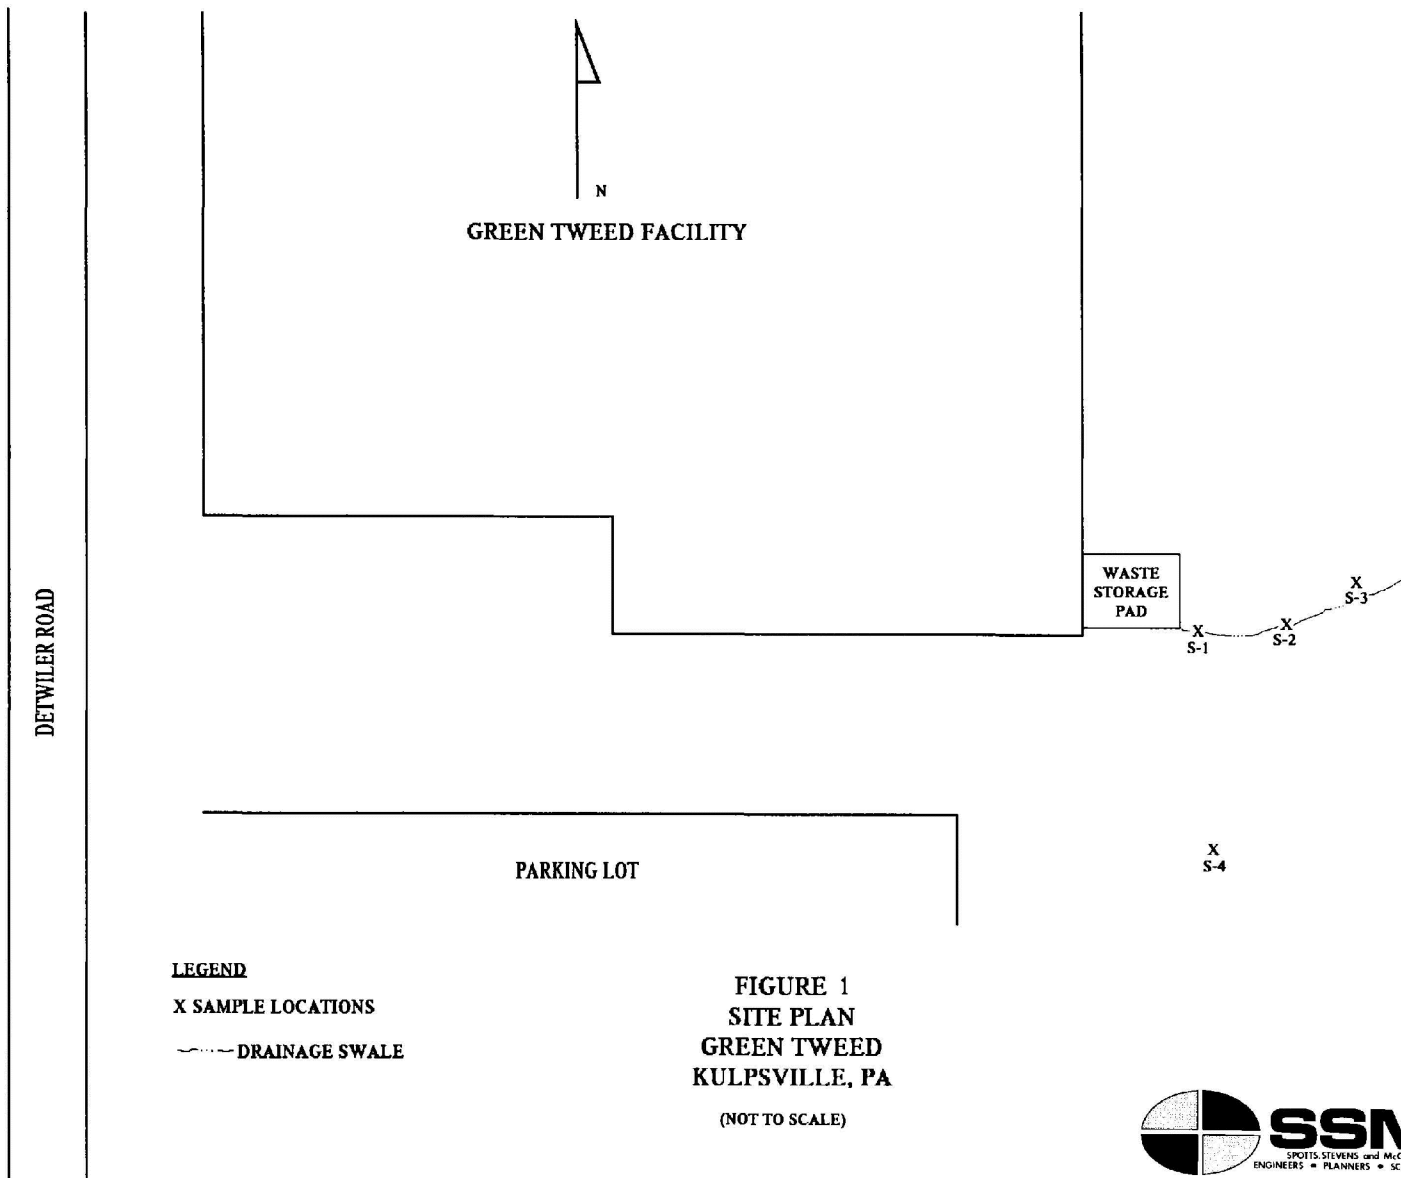
**FIGURE 3
 SWMU 1 SOIL SAMPLE LOCATIONS
 GREENE, TWEED & CO.
 KULPSVILLE, PENNSYLVANIA**

According to an August 11, 1992 report prepared by Spotts, Stevens, and McCoy, Inc. (SSM) for the facility, four soil samples were collected in the drainage swale near the former hazardous waste storage area on July 16, 1992. The samples were designated as S-1, S-2, S-3, and S-4 (Appendix B: Figure 3 - SWMU 1 Soil Sample Locations). Sample S-1 was directly downgradient from the drain. Samples S-2 and S-3 were located 15 and 30 feet, respectively, east and downgradient from sample S-1. Sample S-4 was a background sample collected approximately 40 feet south and upgradient from sample S-1. The samples were collected at an approximate depth of one foot below ground surface (bgs) utilizing a bucket auger. Samples S-1, S-2, and S-3 were analyzed for ethanol (ethyl alcohol), toluene, MEK, and total petroleum hydrocarbons (TPH). In addition, sample S-1 was analyzed for arsenic, barium, cadmium, chromium, lead, mercury, selenium, and silver. Sample S-4 was analyzed for TPH only. Analytical results indicated that none of the samples contained ethanol, toluene, or MEK at levels above laboratory detection limits. TPH concentrations varied from less than laboratory detection limits (S-2, S-3, and S-4) to 15.4 milligrams per kilogram (mg/kg) (S-1). Arsenic (0.84 mg/kg), barium (91.5 mg/kg), cadmium (0.95 mg/kg), chromium (16.2 mg/kg), lead (16.7 mg/kg), and selenium (0.143 mg/kg) were detected in sample S-1 below levels of environmental concern. The report concluded that the soil adjacent to the former hazardous waste storage area had not been adversely impacted by rainwater runoff from the concrete pad and no further action was required.

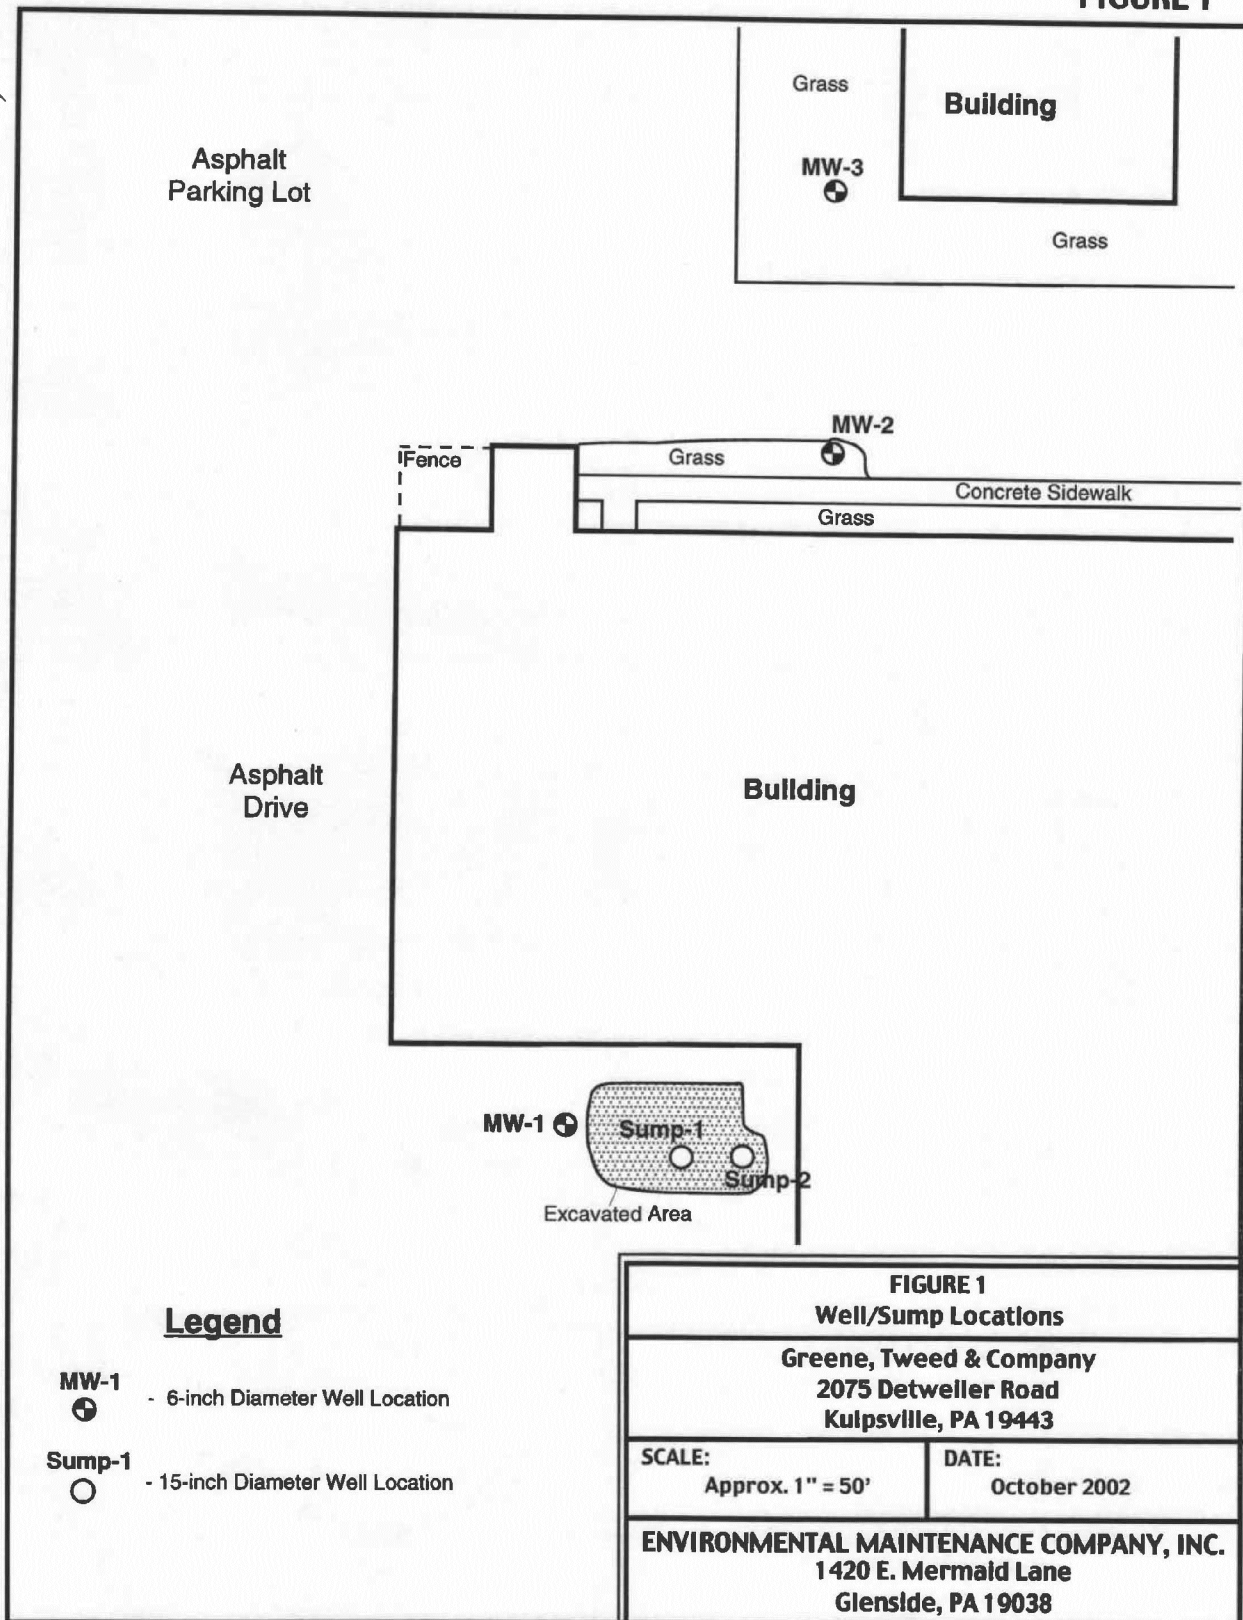
**FIGURE 4
WELL/SUMP LOCATIONS
GREENE, TWEED & CO.
KULPSVILLE, PENNSYLVANIA**

PADEP conducted an inspection and on February 11, 2002 and sent the facility guidance to properly close the USTs and achieve compliance with the Clean Streams Law. The two USTs were removed between February 23 and 26, 2002. Impacted soil and free product were observed around the former UST locations. The impacted soil extended to weathered bedrock which was encountered at approximately five feet bgs within the excavation. Impacted material was removed from the excavation and properly disposed (Appendix B: Figure 4 - Well/Sump Locations).

Prior to backfilling the excavation and to allow for the monitoring and/or remediation of groundwater within the excavated area, two 15-inch diameter slotted sumps (Appendix B: Figure 4 - Well/Sump Locations) were installed in the excavation. The locations of the sumps were chosen based on the areas of anticipated product accumulation so that continued shallow groundwater remediation efforts would have the greatest impact. Following the installation of the sumps, several remedial purge events (RPEs) were conducted at both sumps as a continued groundwater remediation measure.

Groundwater Sampling and Analytical Results - 2009 Final Report: Groundwater samples were collected from Sump 1 and Sump 2 installed within the excavation prior to backfilling during four events conducted between October 2002 and August 2003 (Appendix B: Figure 4 - Well/Sump Locations). The groundwater samples were analyzed for the PADEP Short List of Petroleum Products for No. 2 and No. 4 fuel oil. The analytical data indicated several of the COCs were present at concentrations below the applicable used aquifer residential MSCs. Specifically, concentrations of naphthalene (non-detect to 3 micrograms per liter [ug/L]), fluorene (non-detect to 0.5 ug/L), phenanthrene (non-detect to 0.7 ug/L), and pyrene (non-detect to 0.4 ug/L) were detected in both monitoring points during more than one sampling event, while concentrations of toluene (1 ug/L), anthracene (0.7 ug/L), and benzo(a)anthracene (0.1 ug/L) were only detected during one event and only in one of the two sumps. None of the target analytes were detected in the groundwater samples collected from the two sumps during the August 2003 sampling event.

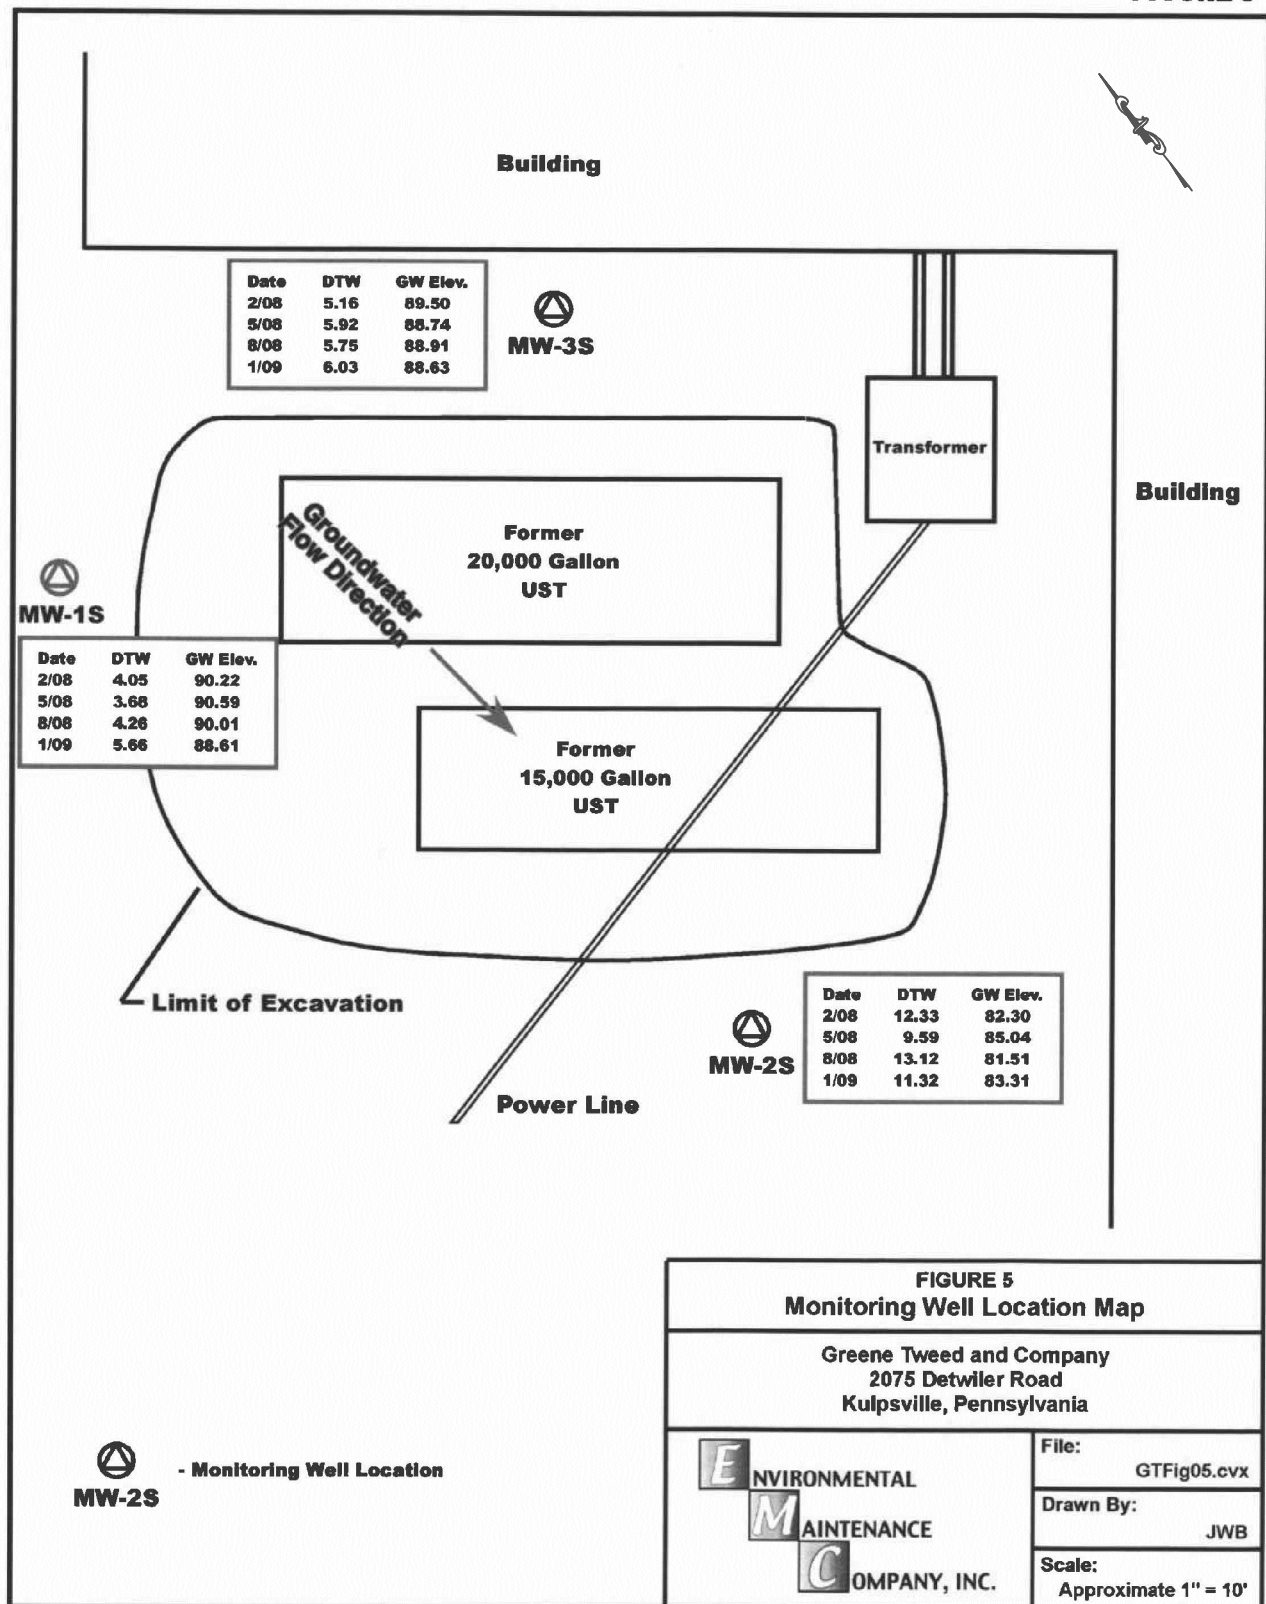
FIGURE 5
MONITORING WELL LOCATIONS
GREENE, TWEED & CO.
KULPSVILLE, PENNSYLVANIA

On February 18, 2004, EMC sent PADEP a work plan for the installation of additional shallow monitoring wells to demonstrate attainment under Act 2. On March 1, 2004, PADEP acknowledged the work plan. In February 2008, EMC installed three shallow monitoring wells (MW-1S, MW-2S, and MW-3S) adjacent to the former excavation (Appendix B: Figure 5 - Monitoring Well Locations). Each monitoring well was completed to the depth of the first water bearing zone (15 feet for MW-1S, and 20 feet for MW-2S and MW-3S) and screened across the water table with two-inch diameter slotted well screen.

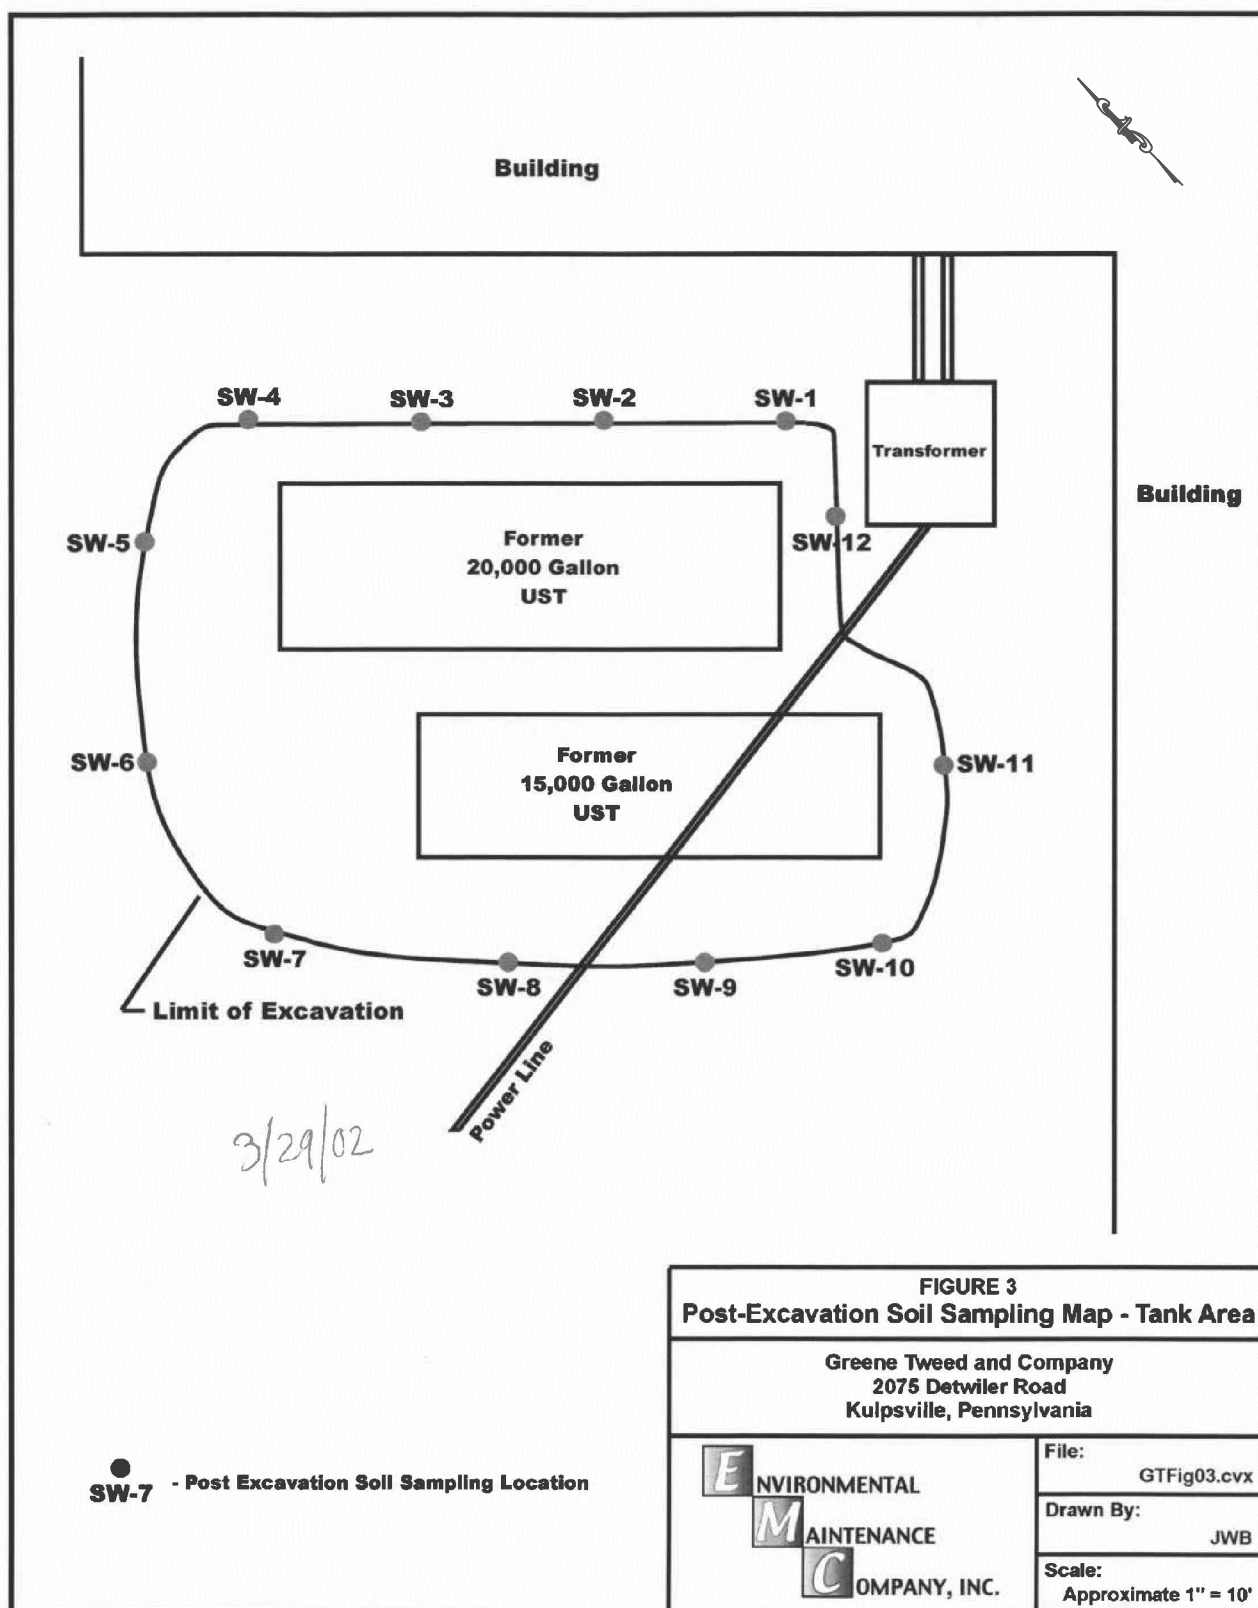
FIGURE 6
POST-EXCAVATION SOIL SAMPLE LOCATIONS - TANK AREA
GREENE, TWEED & CO.
KULPSVILLE, PENNSYLVANIA

Twelve (12) post-excavation soil samples (SW-1 through SW-12) were collected within the UST excavation (Appendix B: Figure 6 - Post-Excavation Soil Sample Locations – Tank Area). The samples were collected from a depth of 4.5 to 5 feet bgs. Nine soil samples (G-1 through G-9) were collected along the drainage swale (Appendix B: Figure 7 - Post-Excavation Soil Sample Locations – Swale Area). The samples were collected from a depth of 0.5 to 1 foot bgs. The samples were analyzed for the PADEP Short List of Petroleum Products for No. 2, 4, and 6 fuel oils that included benzene, ethylbenzene, cumene, toluene, naphthalene, anthracene, benzo(a)anthracene, benzo(a)pyrene, benzo(b)fluoranthene, benzo(g,h,i)perylene, chrysene, fluorene, phenanthrene, and pyrene utilizing USEPA Methods 5035/82608 and 8270C.
